## City of Caldwell Parks and Recreation Bridge Inspection Report

| Bridge ID Number: | CPedTrussSE | Location: | Near Indian Creek Plaza |
| Waterway: | Indian Creek | Longitude: | 116d 41' 21.7" |

Date: 6/30/2026

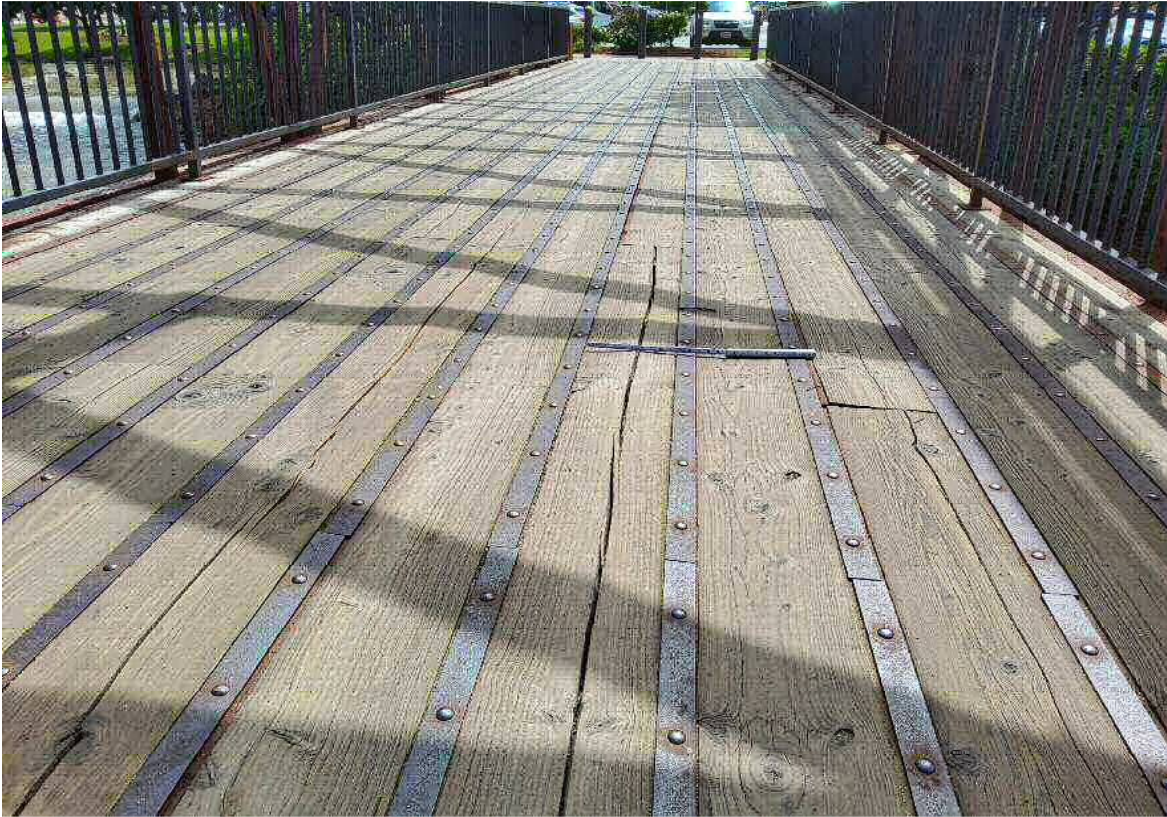
**TIMBER DECK:** Deck consists of 11 x 1 1/2-inch untreated longitudinal timber planks. Planks float free; not attached to floor beams. Timber deck planks are clamped at their longitudinal joints using steel plates on the top and underside, bolted through. The steel plates are painted on the deck surface with approximately 95% paint failure. Timber deck is in satisfactory condition with weathering and minor checking throughout. (8) Planks have longitudinal checks/splits extending through the full depth of the member, up to 1/2-inch wide. Some planks are slightly loose, and some are warped.

Description:  
Full depth  
checking in  
bridge deck

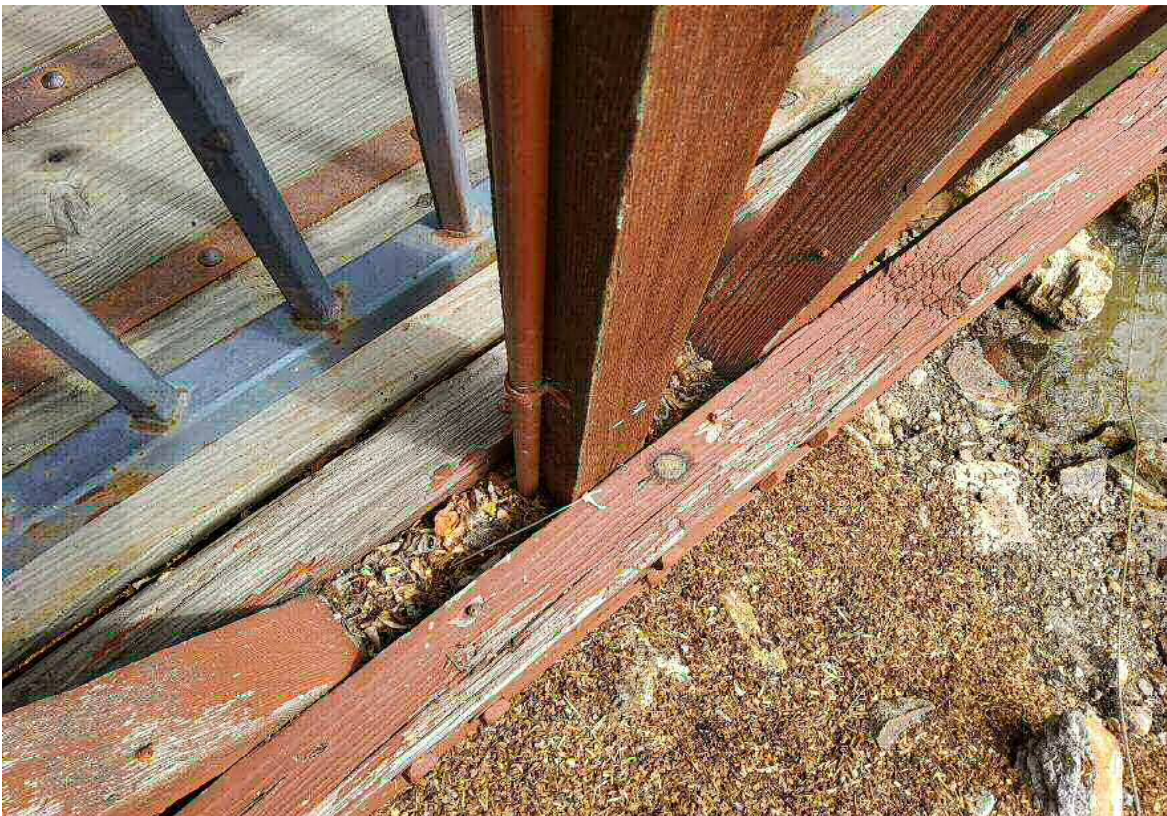
All lower chord connections have dirt and debris accumulation causing minor rot/soft wood at the surface of the members. The upstream L3 connection has moderate rot in the lower chord, vertical, and diagonal members with up to approximately 20% section loss (see sketch). The bottom chord connection locations (US L3, US L11, US L15, DS L7, DS L11, DS L13) have checks/splits up to 1/2-inch wide and extending through the full depth of the member, typically along the bolt line.

Description:  
Typical debris  
and dirt build-up  
at lower chord  
connections

- 1) Perform a comprehensive load analysis based on section loss/deterioration and new load standard.
- 2) Replace the steel floor beams.
- 3) Rehab/repair the rotted areas of the timber truss (mainly along the lower chord).
- 4) Open up lower chord connections (hole saw) to prevent debris accumulation.
- 5) Clean debris from lower chord connections routinely.
- 6) Replace the downstream L9-U10 diagonal.
- 7) Paint timber elements with a UV resistant paint; maintain regular painting schedule.
- 8) Stop use of deicing salts. Consider alternate decking that does not require deicing, or add protective membrane between deck and floor beams.
- 9) Consider future bridge replacement.
- 10) Implement regular inspection interval.

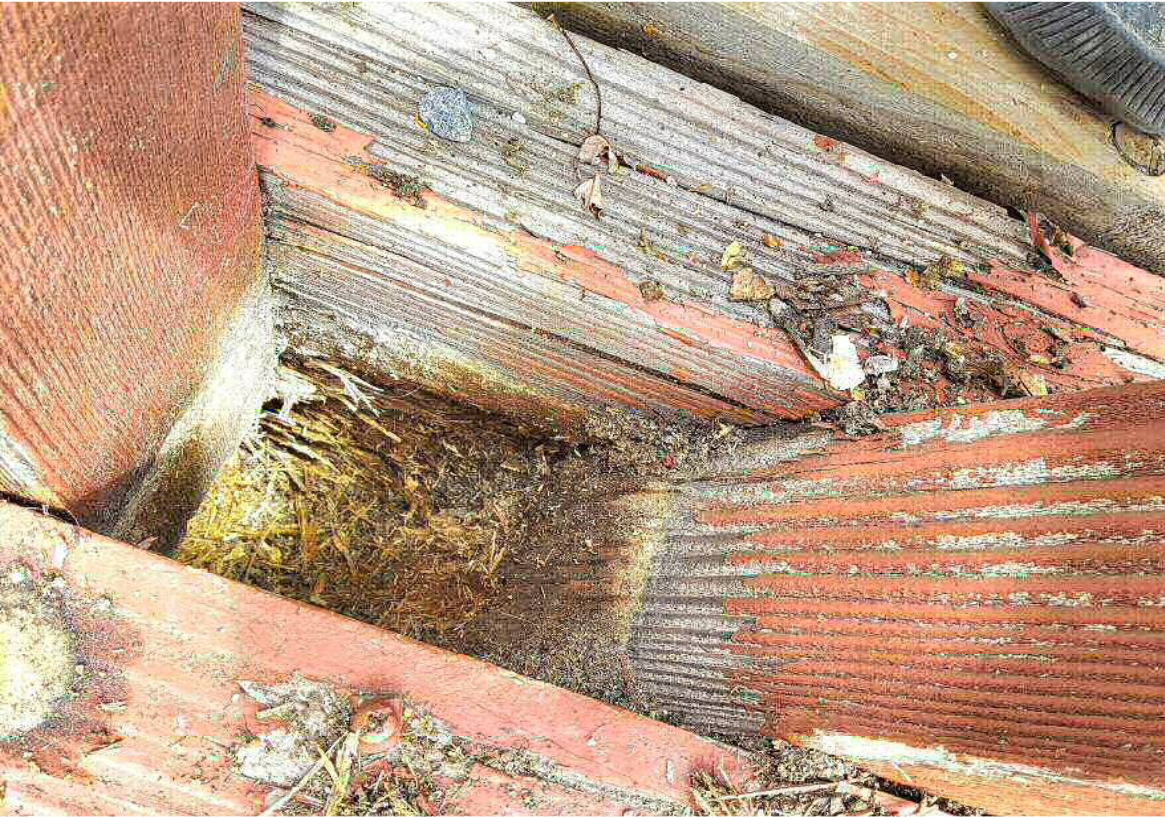
Description:  
Rotting of  
members at  
internal section  
of US L3 lower  
chord  
connection

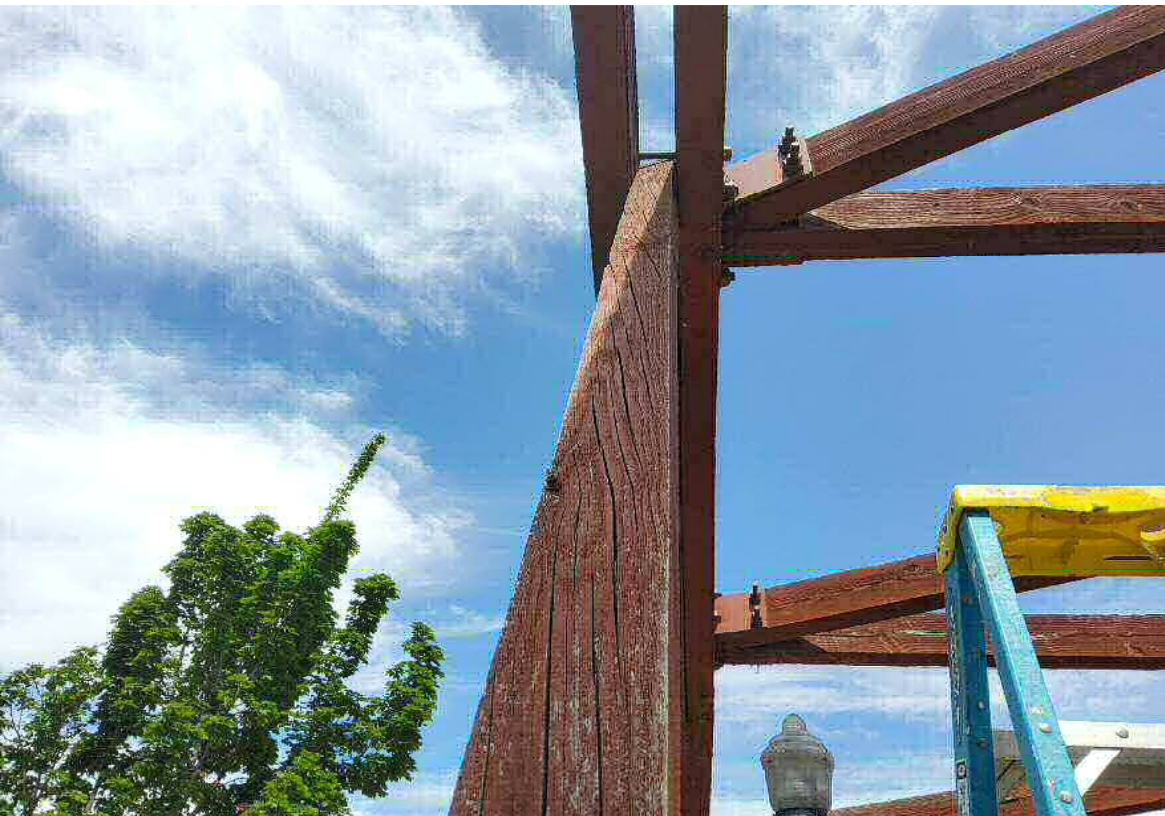
Description:  
DS L9-U10  
diagonal slightly  
rotated with  
checking and  
weathering  
throughout

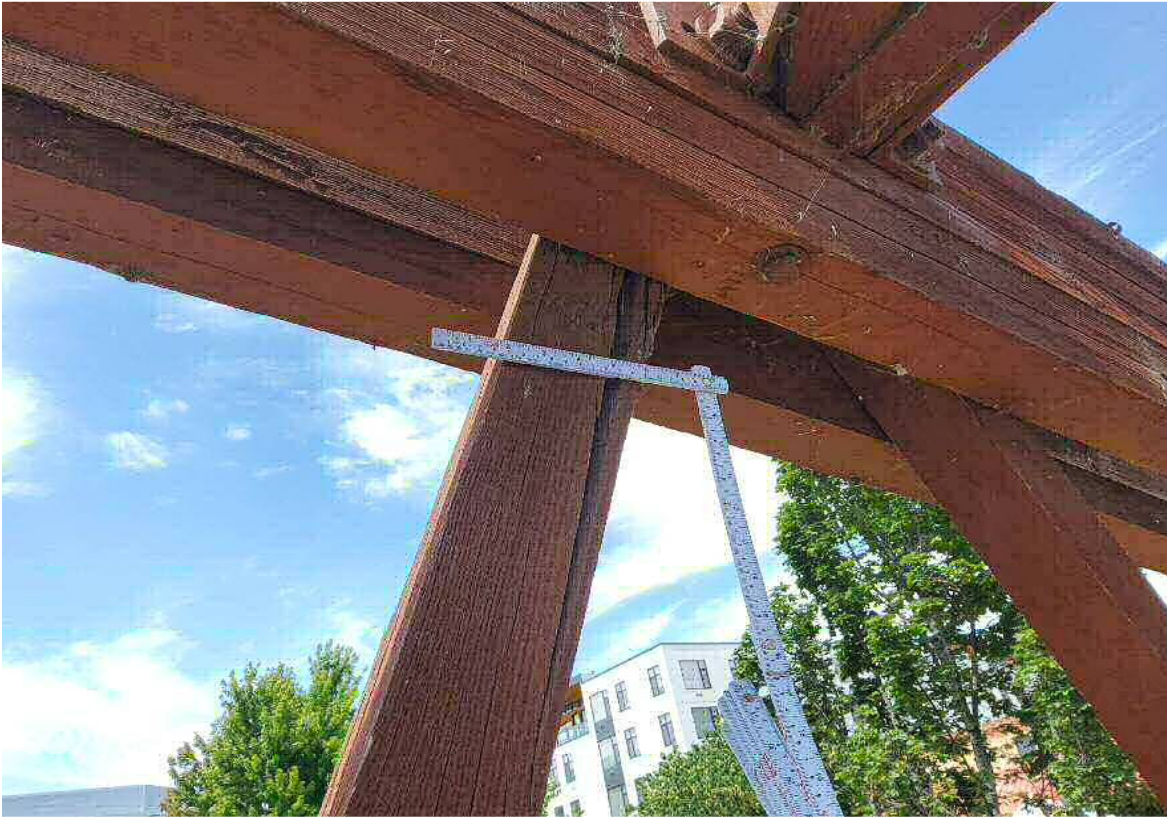
The top chords have general weathering and delaminations along the top up to 3/8-inch deep, typical checking up to 3/16-inch wide, and gaps in the laminations up to 3/8-inch wide. Several of the diagonals have minor splits at the upper ends due to the through bolts. The downstream L9-U10 diagonal is rotated slightly with moderate checking throughout and a 3-feet long x 1/2-inch wide split at U10.

Description:  
Split in end of  
DS L9-U10  
diagonal at U10

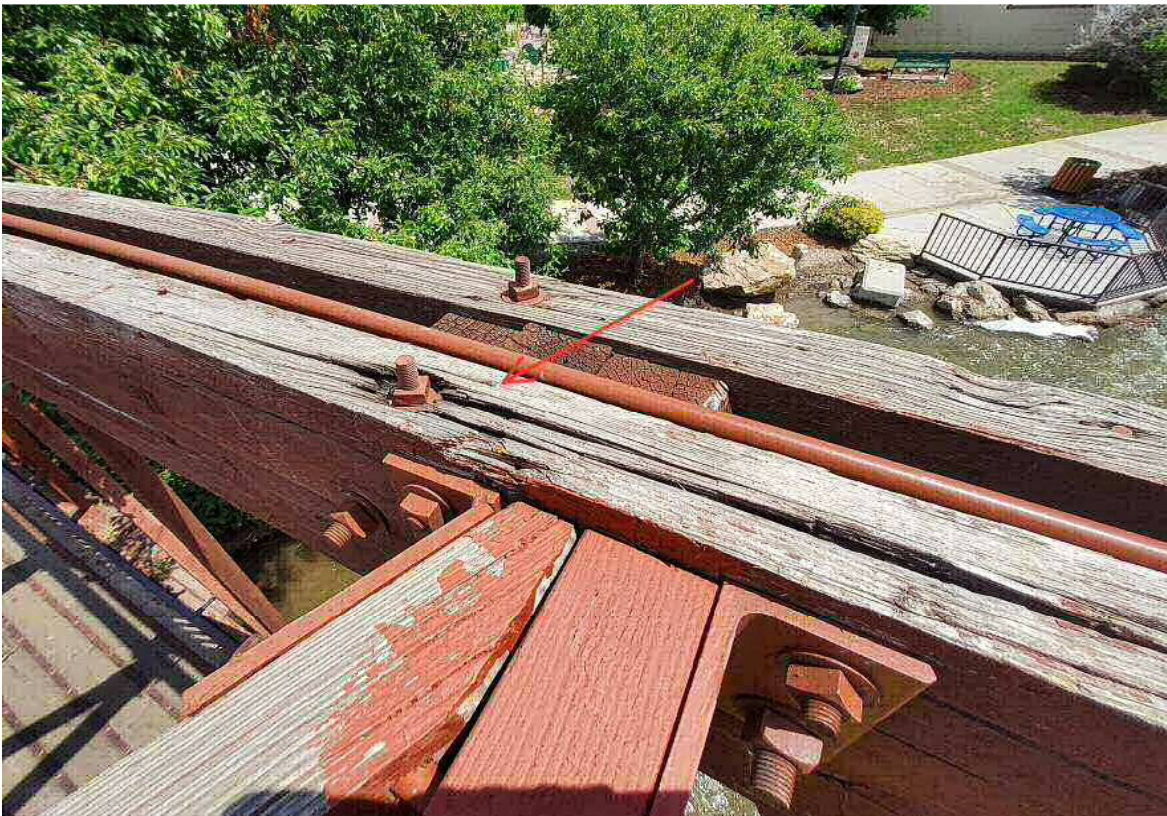
Description:  
Rotting and  
crushing at bolt  
at top chord US  
U8 connection

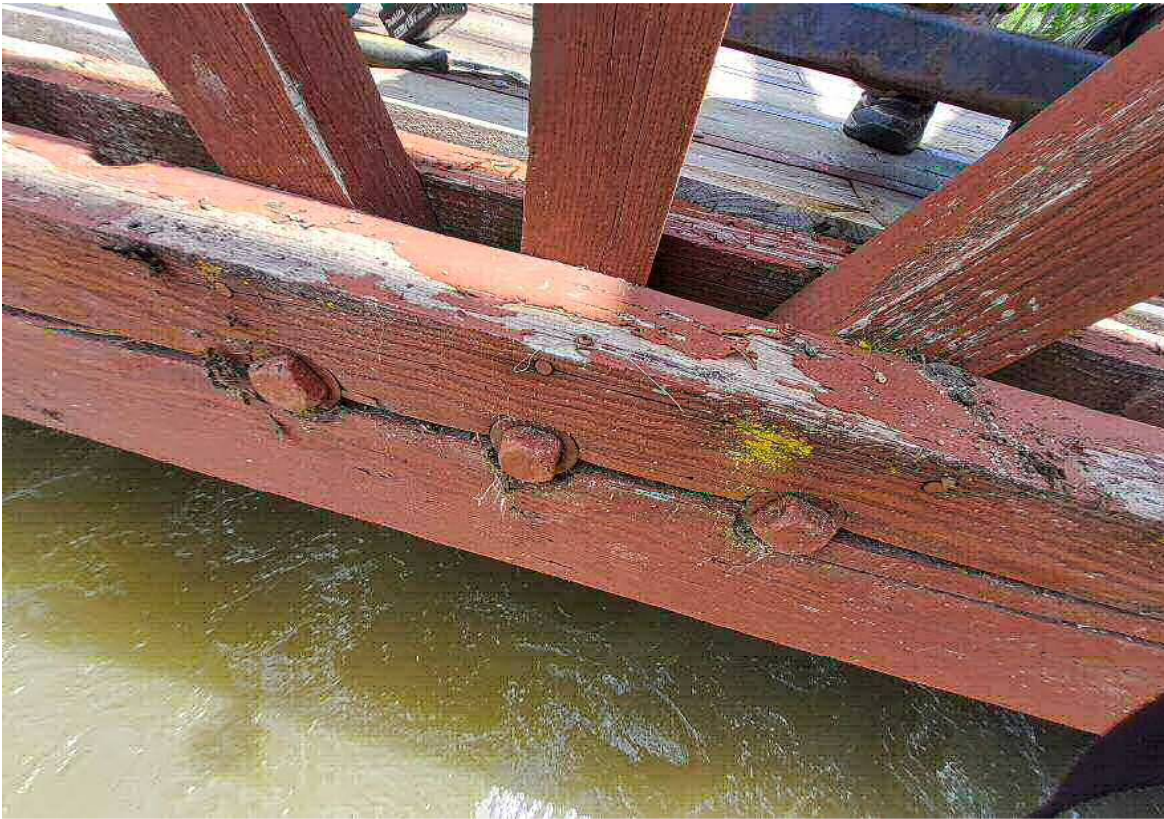
Description:  
Wide check full  
depth at DS L7  
lower chord  
connection with  
some crushing  
at bolts

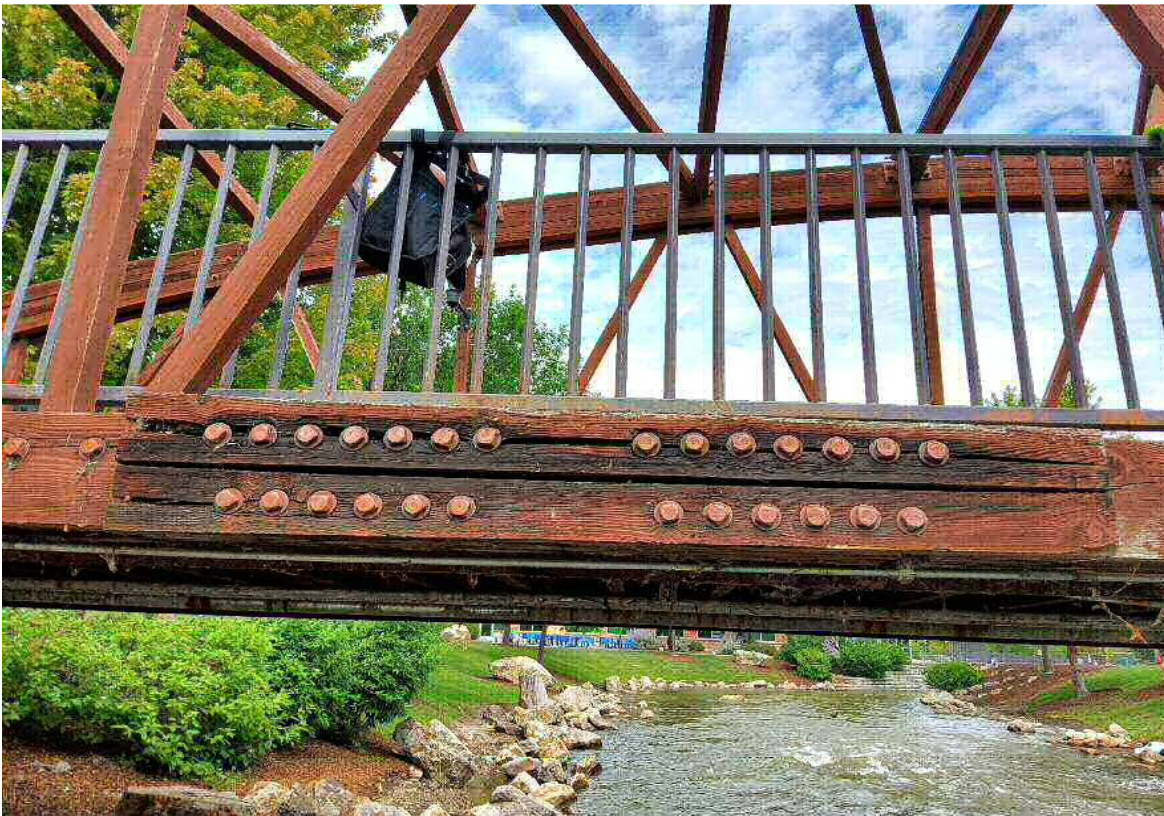
The (4) splice locations have checking/splitting on the exterior boards; worse at the SE splice extending through the full depth of the member, up to 3/4-inch wide with some crushing at the bolt heads. Bolt pullout strength greatly reduced.

Description:  
Splice plate with  
checking and  
crushing at SE

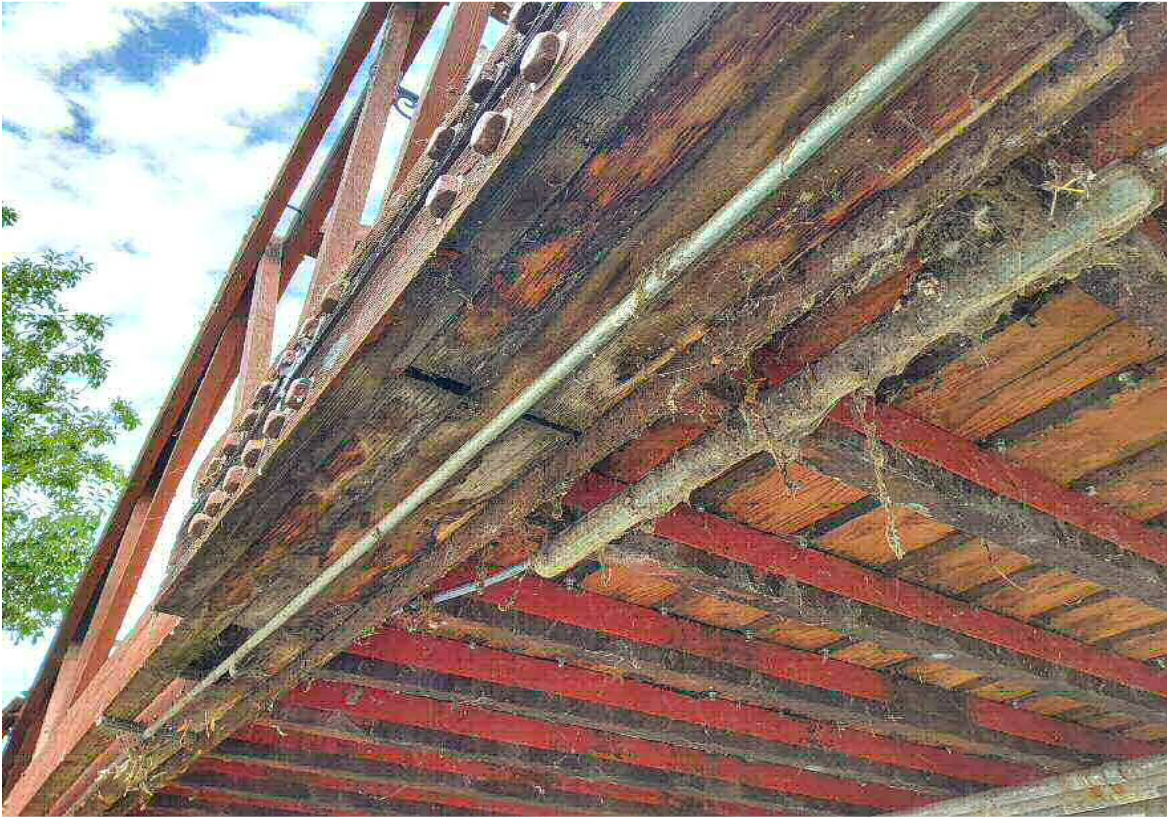
Description:  
Underside view  
of splice plate  
with  
discoloration at  
SE

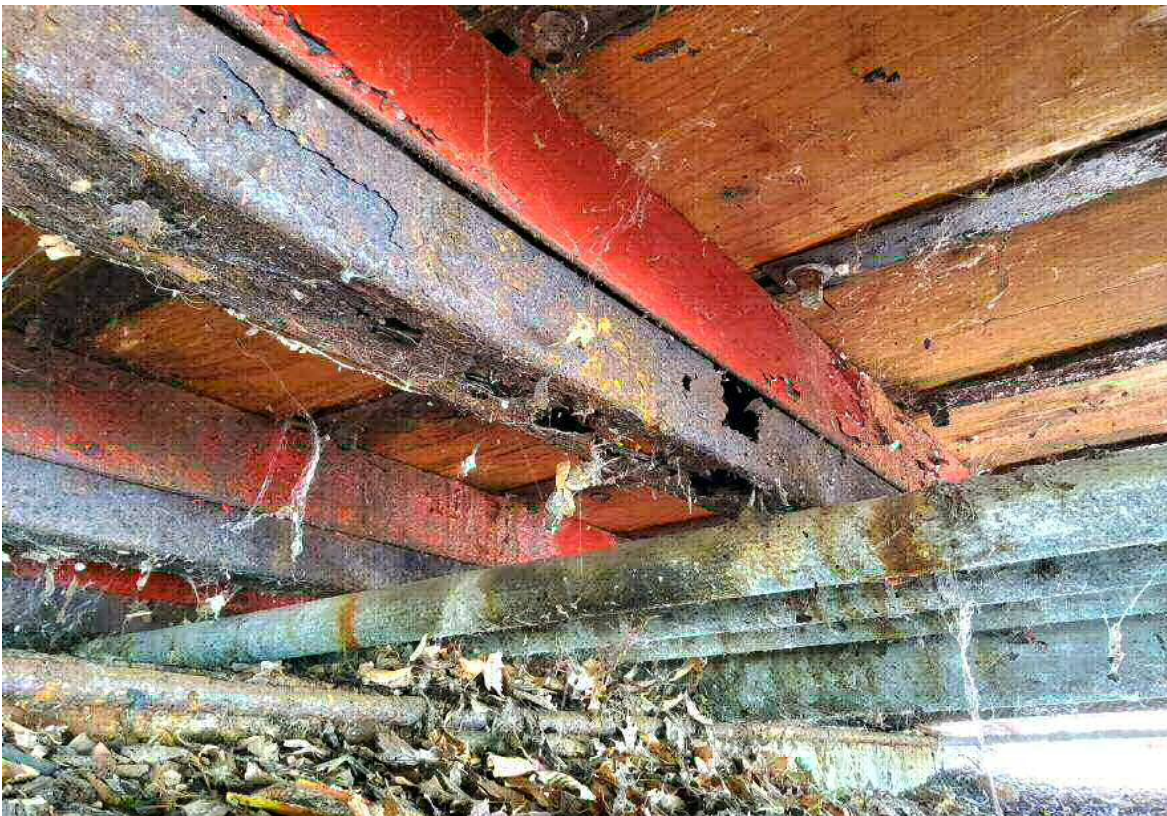
**STEEL FLOOR BEAM:** (57) Steel floor beams welded to steel plate at the lower chord run transverse. Floor beams are 3 inch x 6 inch x 3/16 inch wall rectangular steel tube. Timber deck rests on floor beams. Floor beams are in serious condition. Floor beams are numbered from SW to NE. All floor beams have major corrosion with pitting and section loss throughout. Majority of beams have up to 0.071 inch section loss (approximately 42% of wall thickness). (5) Beams have severe section loss up to 100% of the web and flange thickness resulting in visible holes through the member in both the web and the flanges. These beams are assumed to have negligible load bearing capacity. (Beams with full depth section loss: FB 3, FB 15, FB 34, FB 55, FB 57), see sketch. Floor beam corrosion is highly accelerated due to presence of moisture and deicing salts used in winter maintenance.

Description:  
Total section  
loss in floor  
beam 3

| FB | Thick | Orig Thick | % Loss |
|---|---|---|---|
| 3 | 0.00 | 0.180 | 100% |

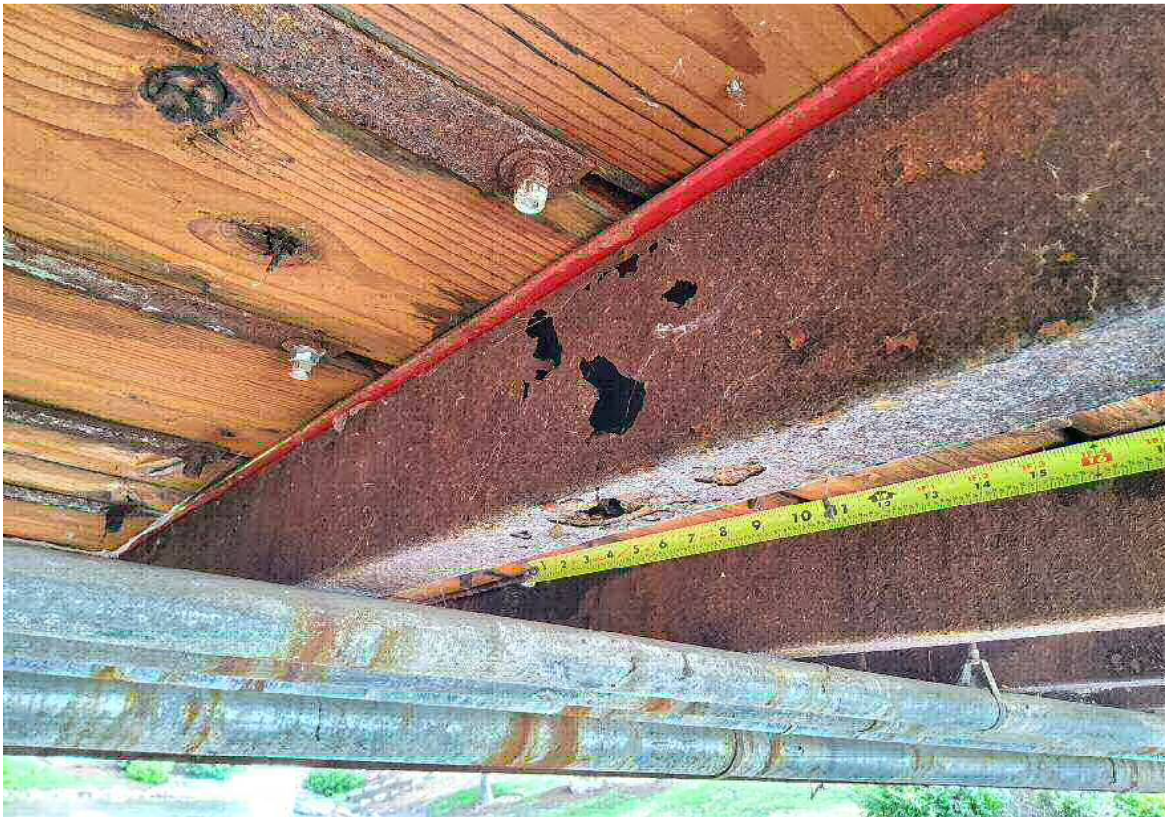
Description:  
Total section  
loss in floor  
beam 15

| FB | Thick | Orig Thick | % Loss |
|---|---|---|---|
| 15 | 0.00 | 0.180 | 100% |

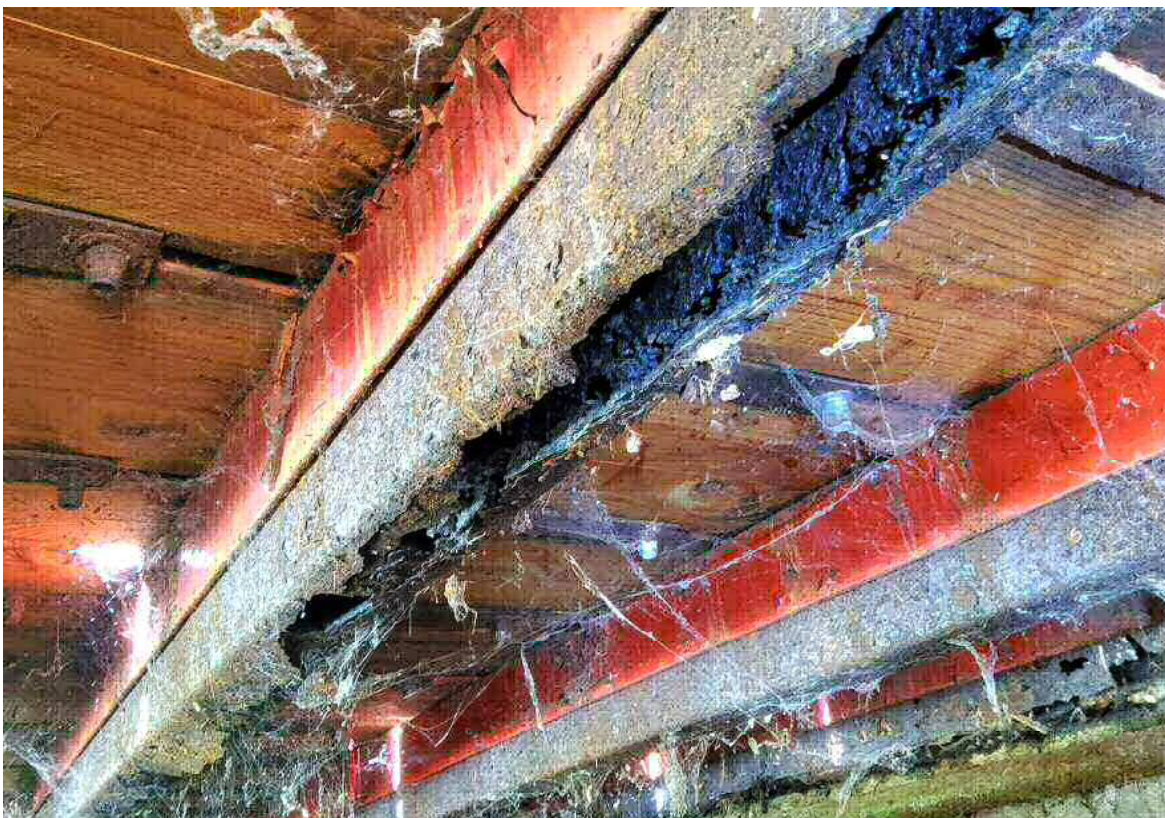
Description:  
Total section  
loss in floor  
beam 55

| FB | Thick | Orig Thick | % Loss |
|---|---|---|---|
| 55 | 0.00 | 0.180 | 100% |

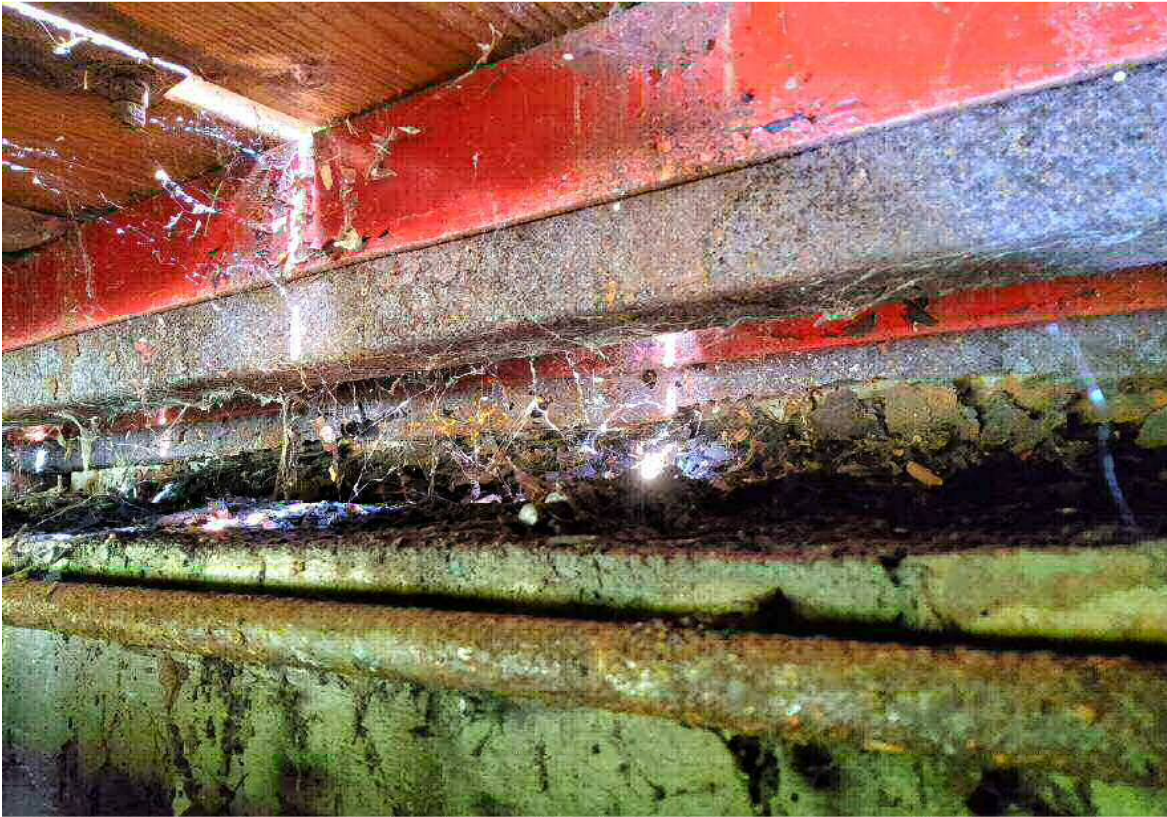
Description:  
Total section  
loss in floor  
beam 57

| FB | Thick | Orig Thick | % Loss |
|---|---|---|---|
| 57 | 0.00 | 0.180 | 100% |

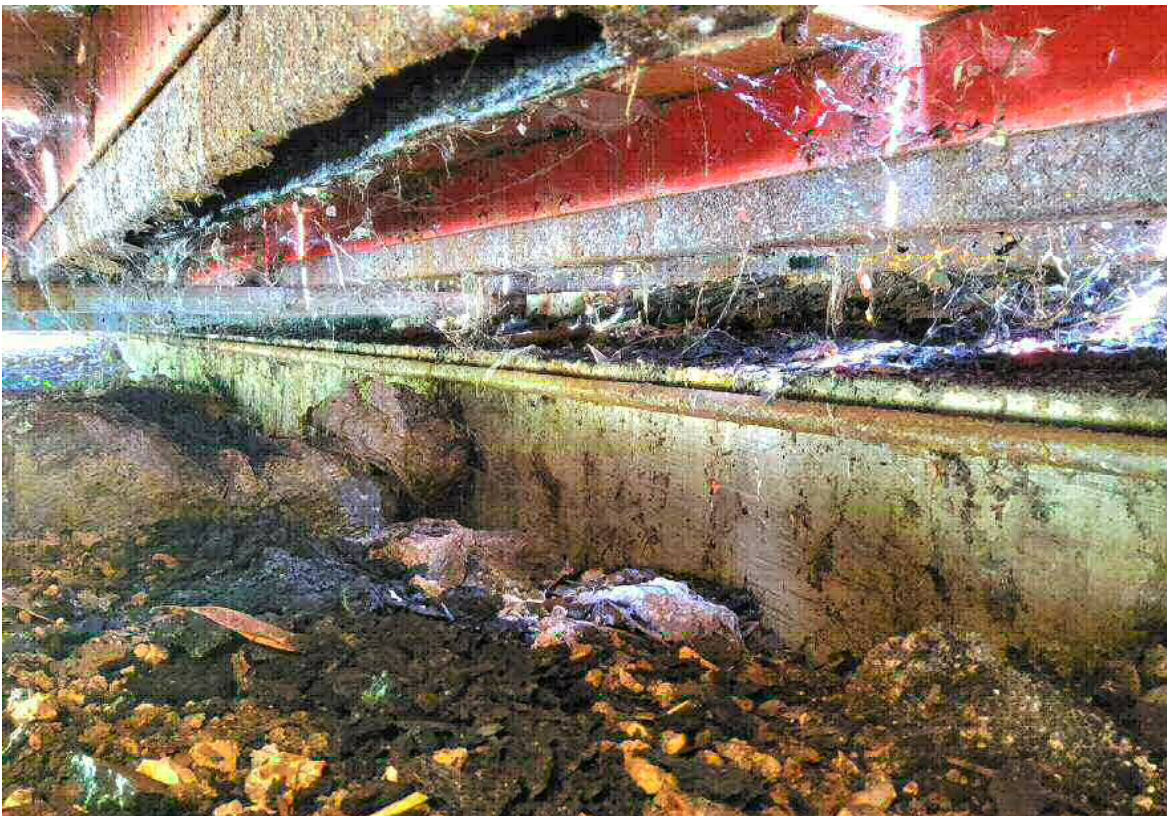
**REINFORCED CONCRETE ABUTMENT:** Reinforced concrete abutments are in good condition. Top of both abutments have dirt and debris accumulation. Only visible at top portion.

Description:  
Overall of north  
abutment

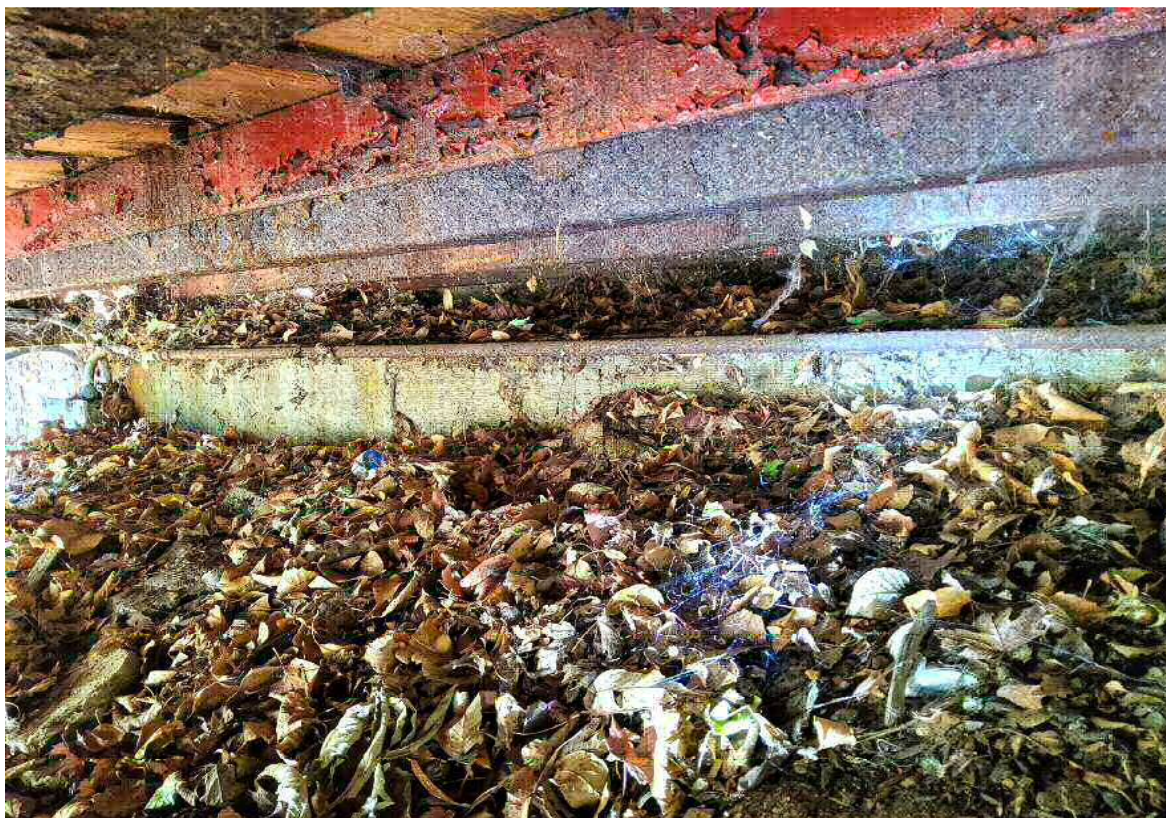
Description:  
Overall of south  
abutment

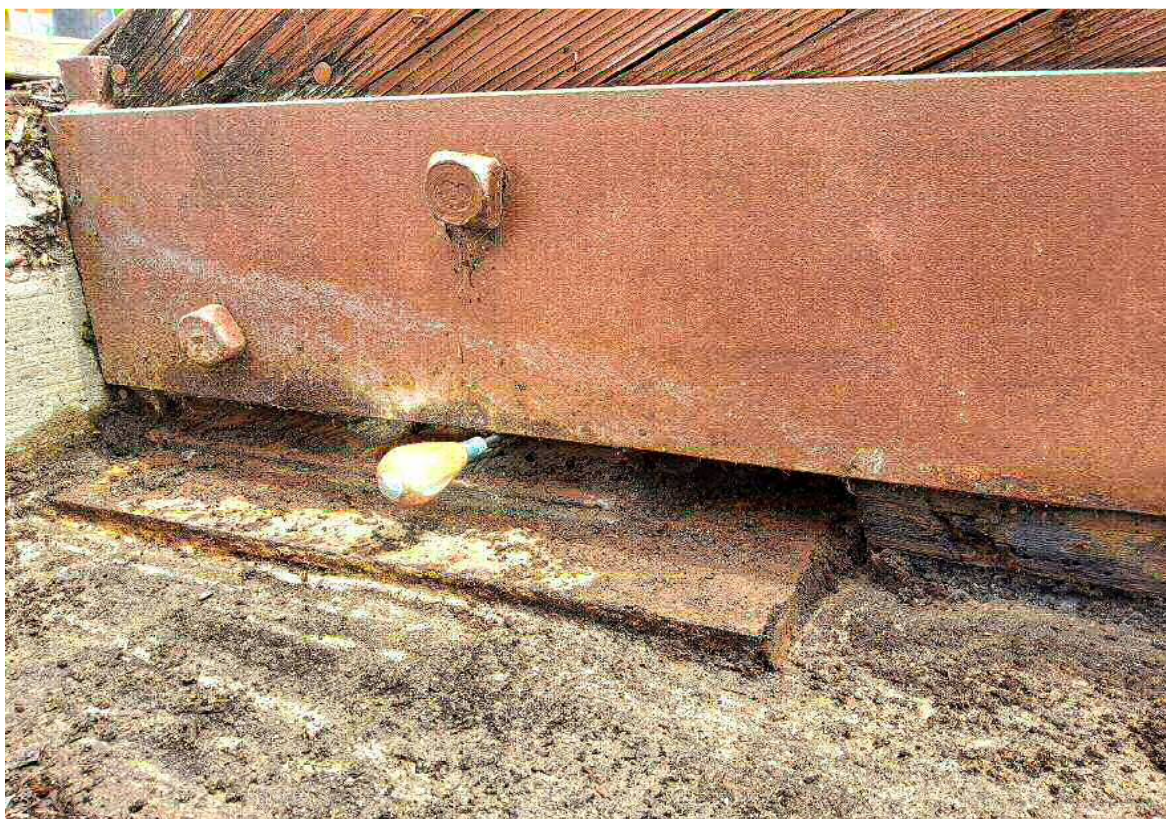
BEARING: Fixed steel plate bearing at NE and sliding steel plate bearing at SW. Corrosion and debris build up on bearing restricts function of sliding plate bearing. Bearings are in poor condition with moderate corrosion, minor pitting, and some areas of minor section loss. Upper arch member bears on steel plate. Timber members are rotted at majority of bearing plate locations with up to 4 inches of penetration with awl.

Description:  
Rotting of timber  
member at  
bearing - north  
end,  
downstream side

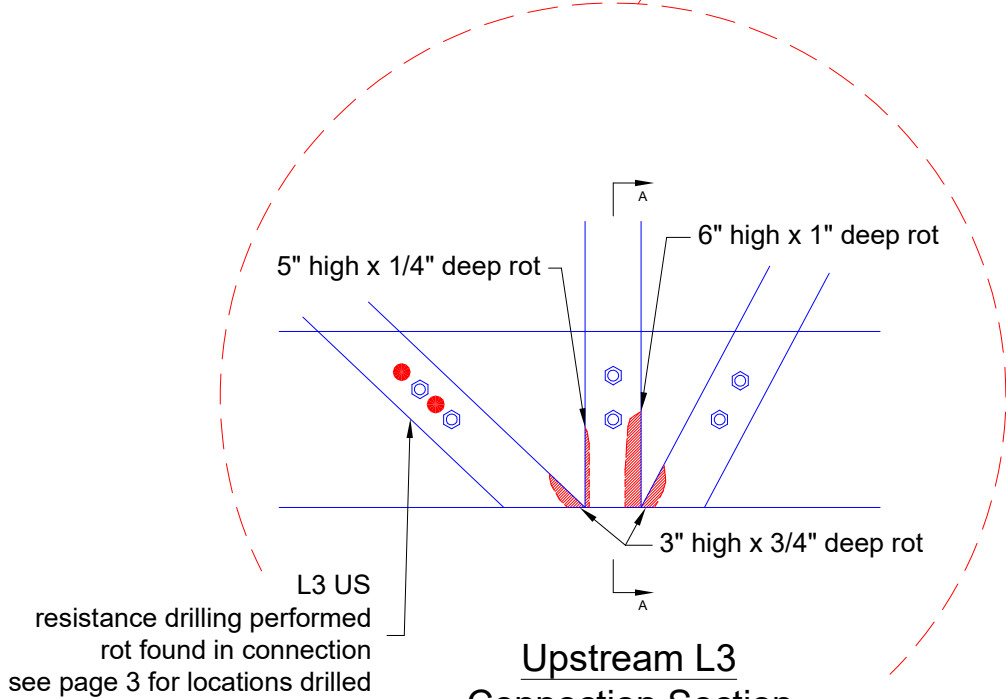
Upstream L3 Connection Section

L3 US  
resistance drilling performed  
rot found in connection  
see page 3 for locations drilled

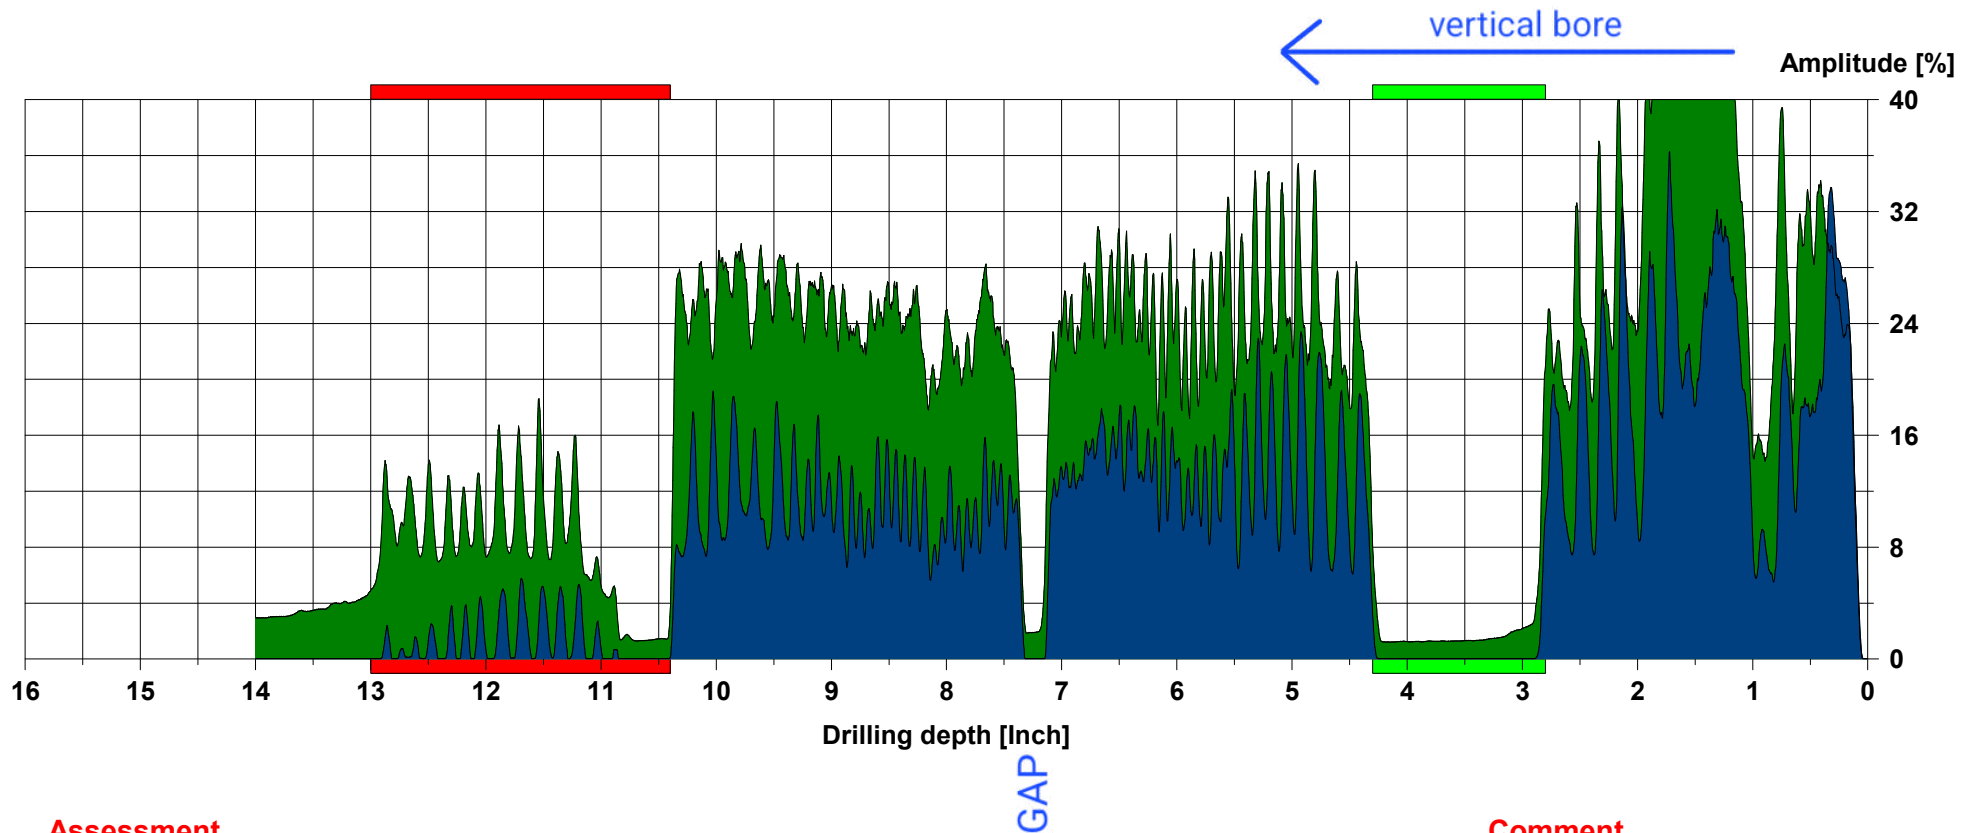
H-0626-01  
SPLICE PLT

| From | 10,40 " | to | 13,00 " | : rot |
| From | 2,80 " | to | 4,30 " | : wide check |

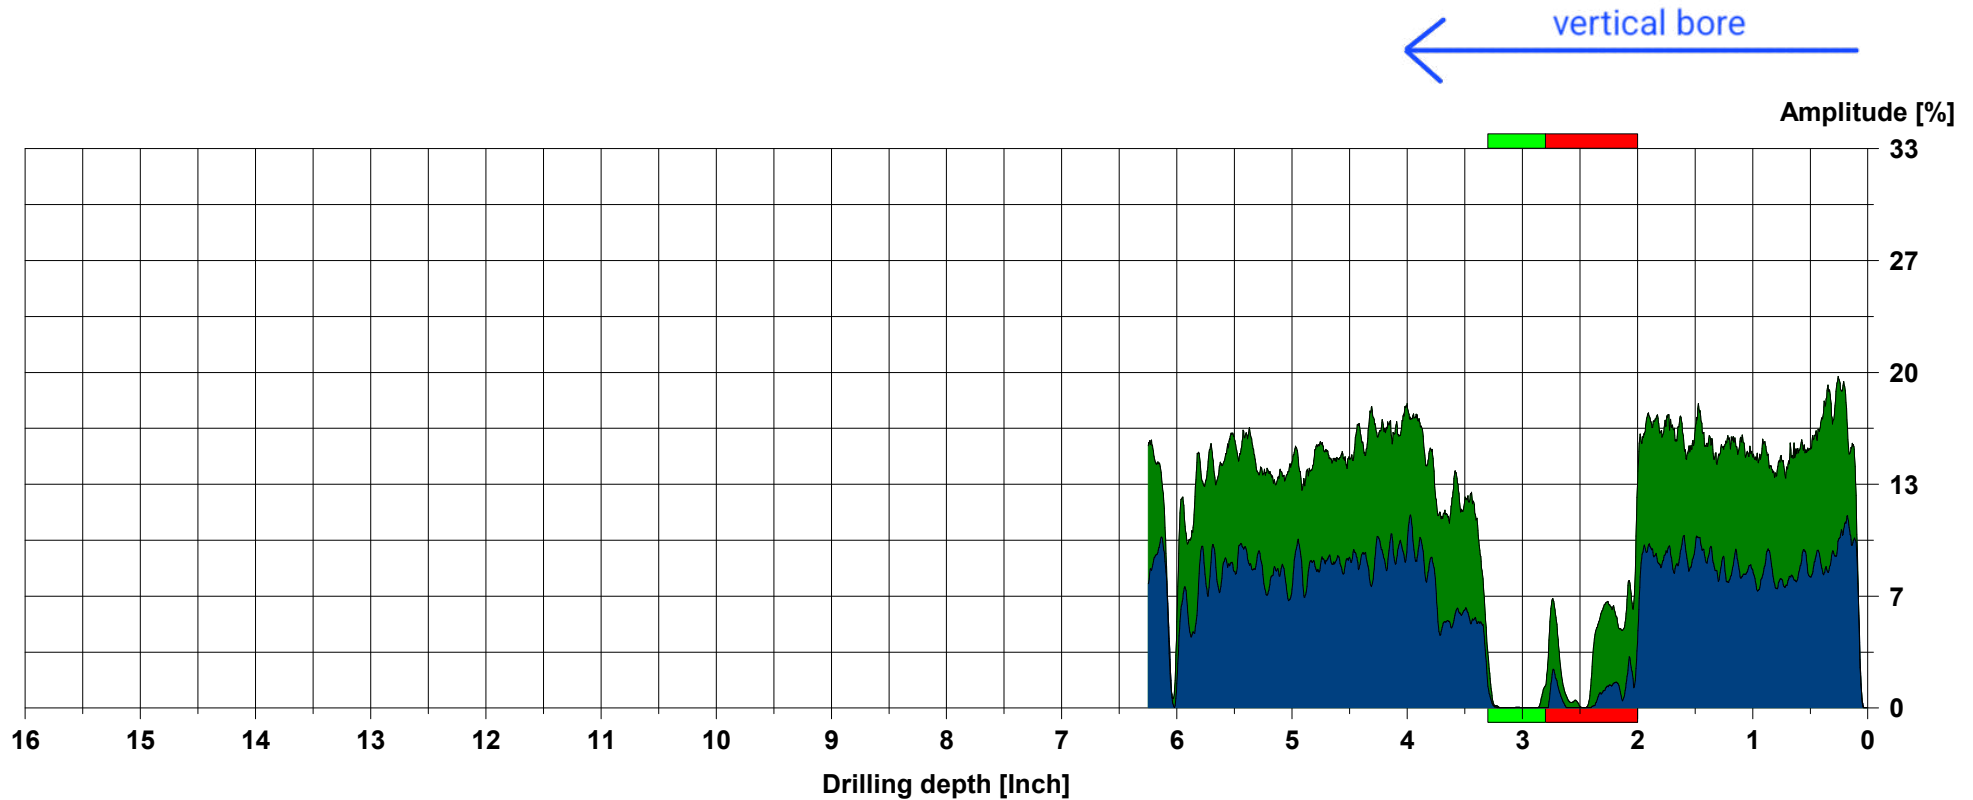
H-0626-09  
SPLICE PLT

| From 2,00 " to 2,80 " : | rot |
| From 2,80 " to 3,30 " : | wide check |

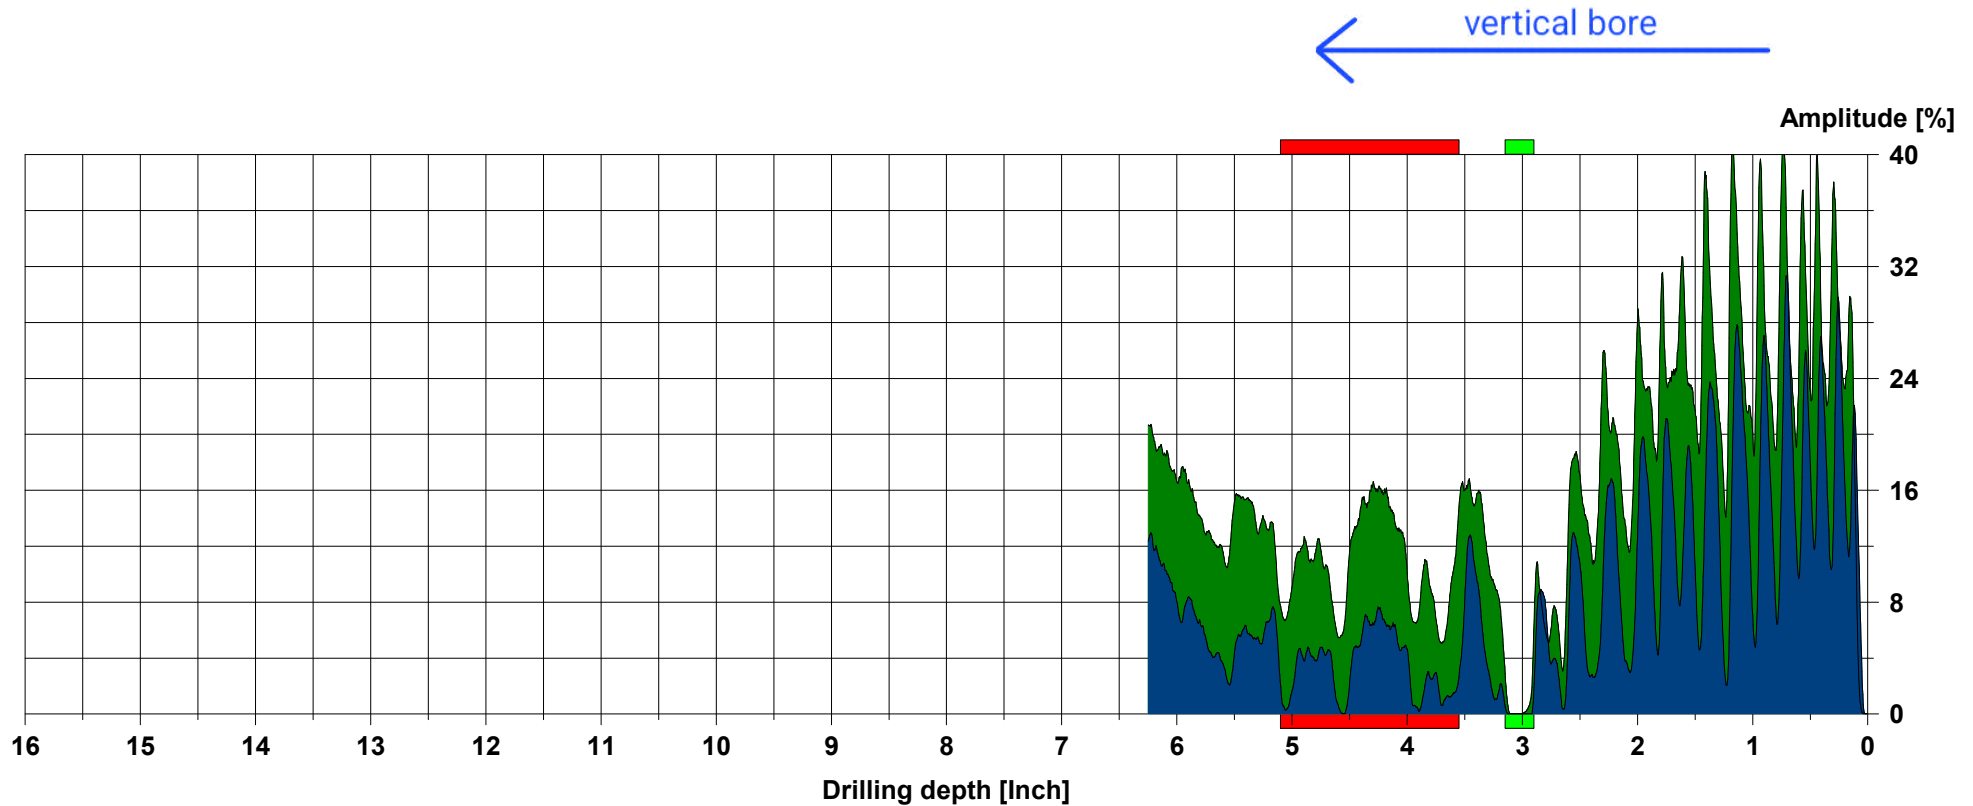
| ■ | From | 3,55 " | to | 5,10 " | : soft wood |
