## City of Caldwell Parks and Recreation Bridge Inspection Report

| Bridge ID Number: | CPedTrussSE | Location: | Near Indian Creek Plaza |
| Waterway: | Indian Creek | Longitude: | 116d 41' 21.7" |

Date: 6/30/2026

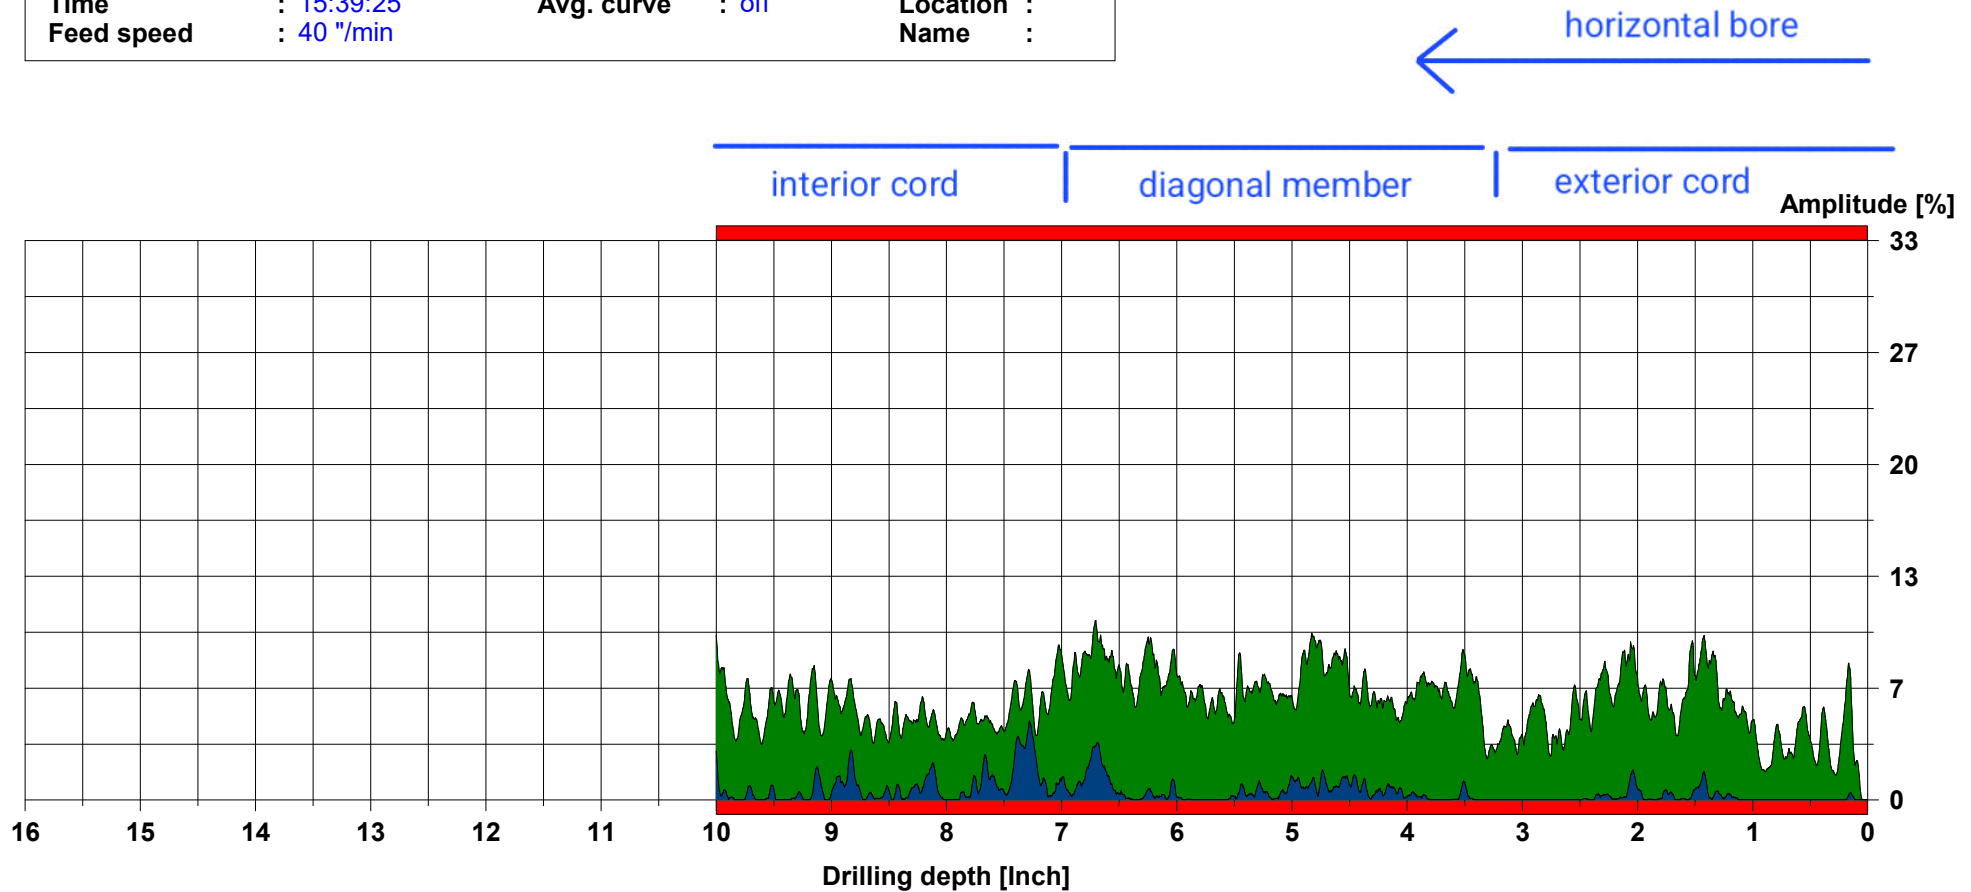
| ■ | From | 0,00 " | to | 10,00 " | : rot |

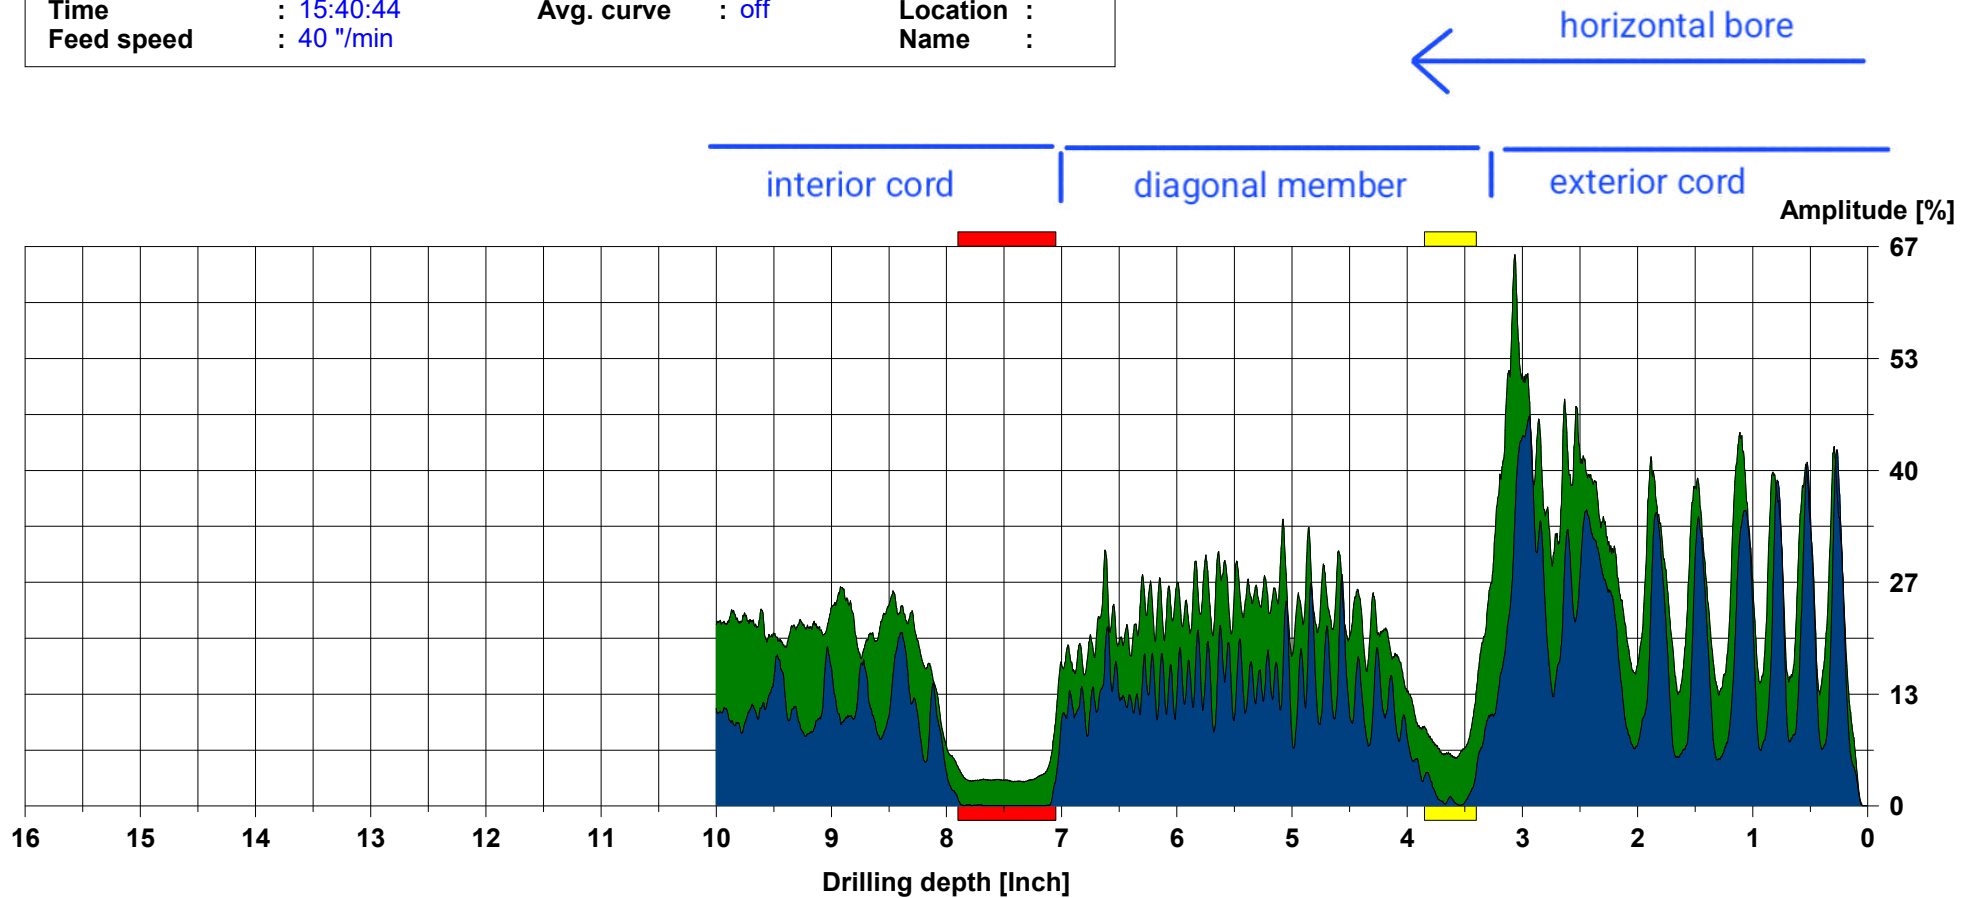
| ■ | From | 7,05 " | to | 7,90 " | : ROT |
| ■ | From | 3,40 " | to | 3,85 " | : ROT |

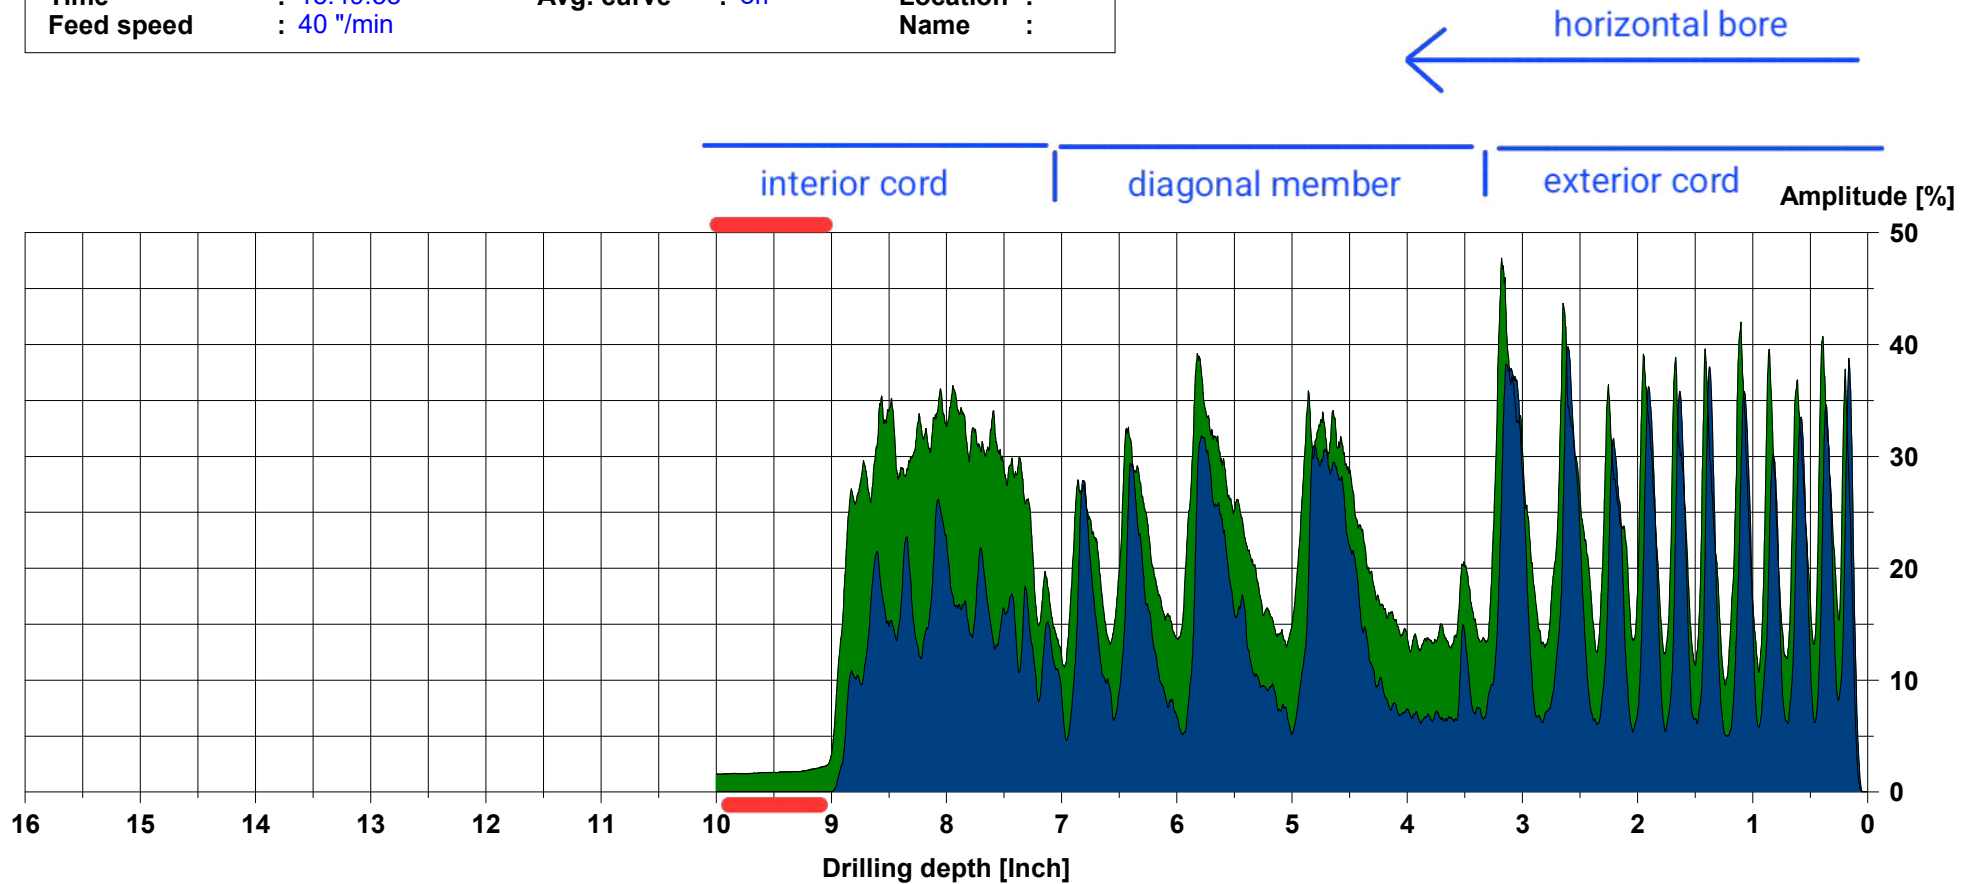
| <input type="checkbox"/> | From | 9.00 " | to | 10.00 " | : | rot |
